Inspection of lead-free advanced packages:
flip chip and chip-scale under control

Verification method for high challenges

Mark Cannon, Jürgen Friedrich, Ersu GmbH

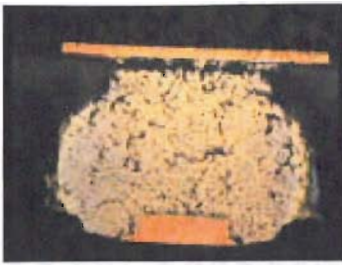
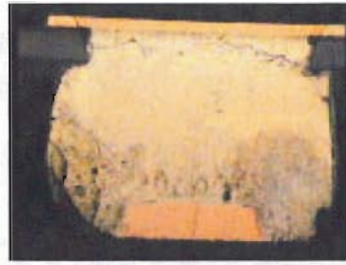
Figure 10: Cracked solder joints for SnPb and SnAgCu alloys due to temperature cycling

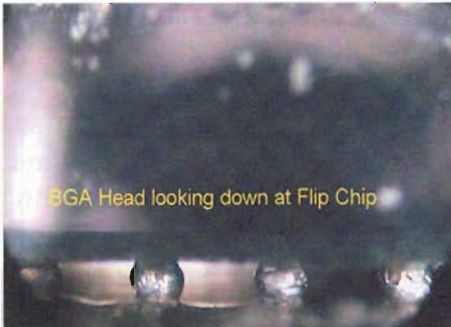
Figure 11: Standard BGA optics looks down at bottom fillet

Low-profile CSPs and FCs will require the improved inspection capabilities of an optical head designed for visual inspection. The iris of the original BGA optical inspection system sits approximately 0.3mm from the surface of the PCB. This provides a "look-down image," as seen in figure 11, of a flip chip whose standoff or gap height is only 0.05mm. The flip-chip optical head has now lowered the iris to approximately 0.015mm. This means that it is now possible to "look up," as seen in figure 12, at even the topside of the flip-chip joint to avoid possible defects such as topside delamination. This critical topside fillet of FCs and CSPs was never before seen by any BGA optical inspection equipment on the market. Figure 12 reveals the importance of this optical innovation by discovering precisely the problem, topside delamination of a low-profile microBGA.

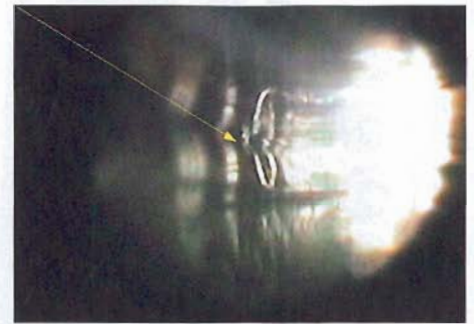
Figure 15: Interior topside fillet deformed

Based on the extremely low iris, the flip-chip optics even allows for the inspection of interior topside fillet problems in the middle of the component, as seen in figures 14 and 15, which were taken from the same microBGA.

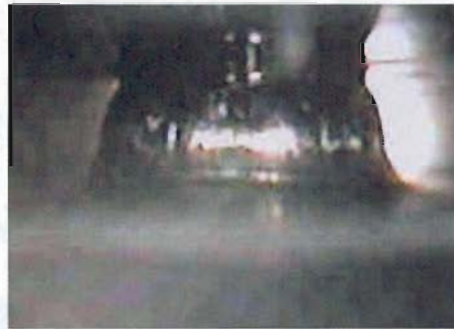
Figure 16: Interior topside fillet OK

The flip-chip optical inspection system has been successfully used to detect critical defects in a production line where lead-free CSPs are used. The topside fillets of a low-profile, lead-free CSP reveals that the middle ball in figure 16 has a proper

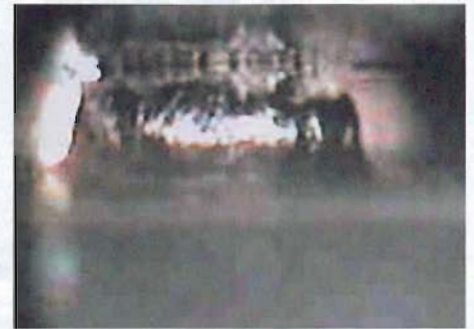
Figure 17: Interior topside fillet delaminated

topside fillet, whereas the left-side corner ball in figure 17 shows obvious delamination. As mentioned before, X ray inspection is up-to-date and a necessary technology for the non-destructive inspection of assemblies. The particular defect of topside delamination, however, is very difficult or impossible to detect with X ray technology, as can be seen in the next images. Figure 18 was taken with the flip-chip optics, whereas figure 19 was taken with modern X-ray equipment. It becomes obvious from these images that an X-ray system alone was not capable of discovering this topside delamination, which resulted for example in a 0.02mm micro crack on a lead-free microBGA. The use of such an optical inspection system which can compliment X-ray use, especially in a lead-free environment, should be considered as a sensible requirement.
